Risk reduction and decision support for financial investments in solar PV projects

Presented at Solar Power Africa
Presented by Lawrence Pratt
lp Pratt@csir.co.za

2022-02-17

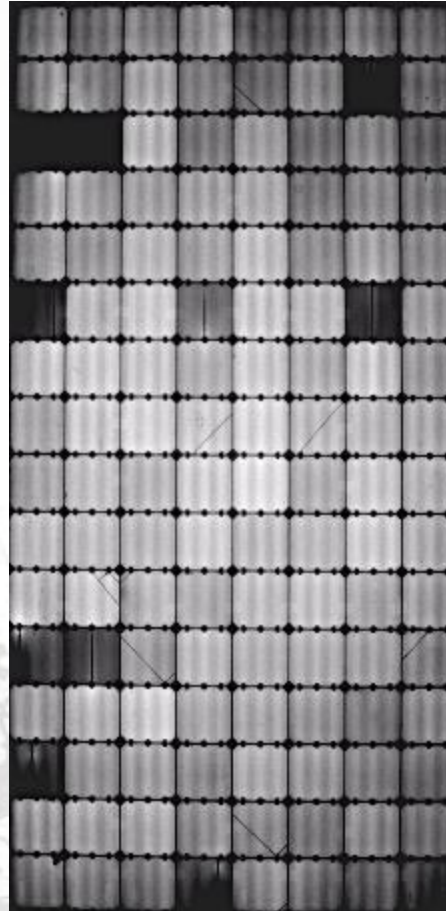
Fig 2: EL image
SunPower-Mono

1. 'X-ray vision' for PV modules
2. EL identifies cracks and dead cells that can impact long-term performance
3. We are developing a machine learning model for defect classification and quantification in EL images

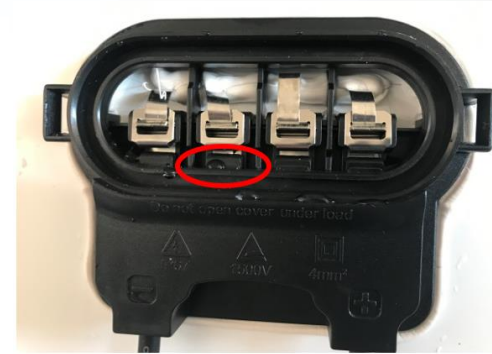
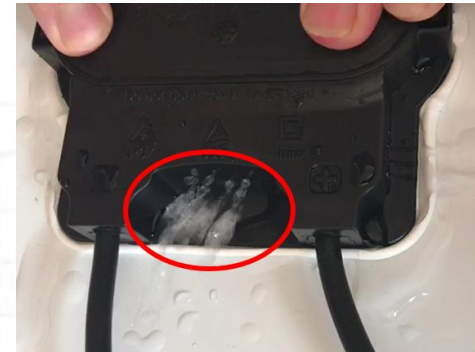
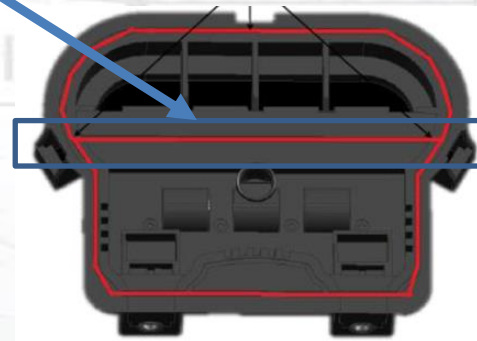
- Batch testing for the CSIR 1 MW rooftop project during pre-construction
- 50% failed the wet leakage test out of the box, pre-stress

Gaps in silicone sealant lead to wet leakage failure around this 'vented' junction box

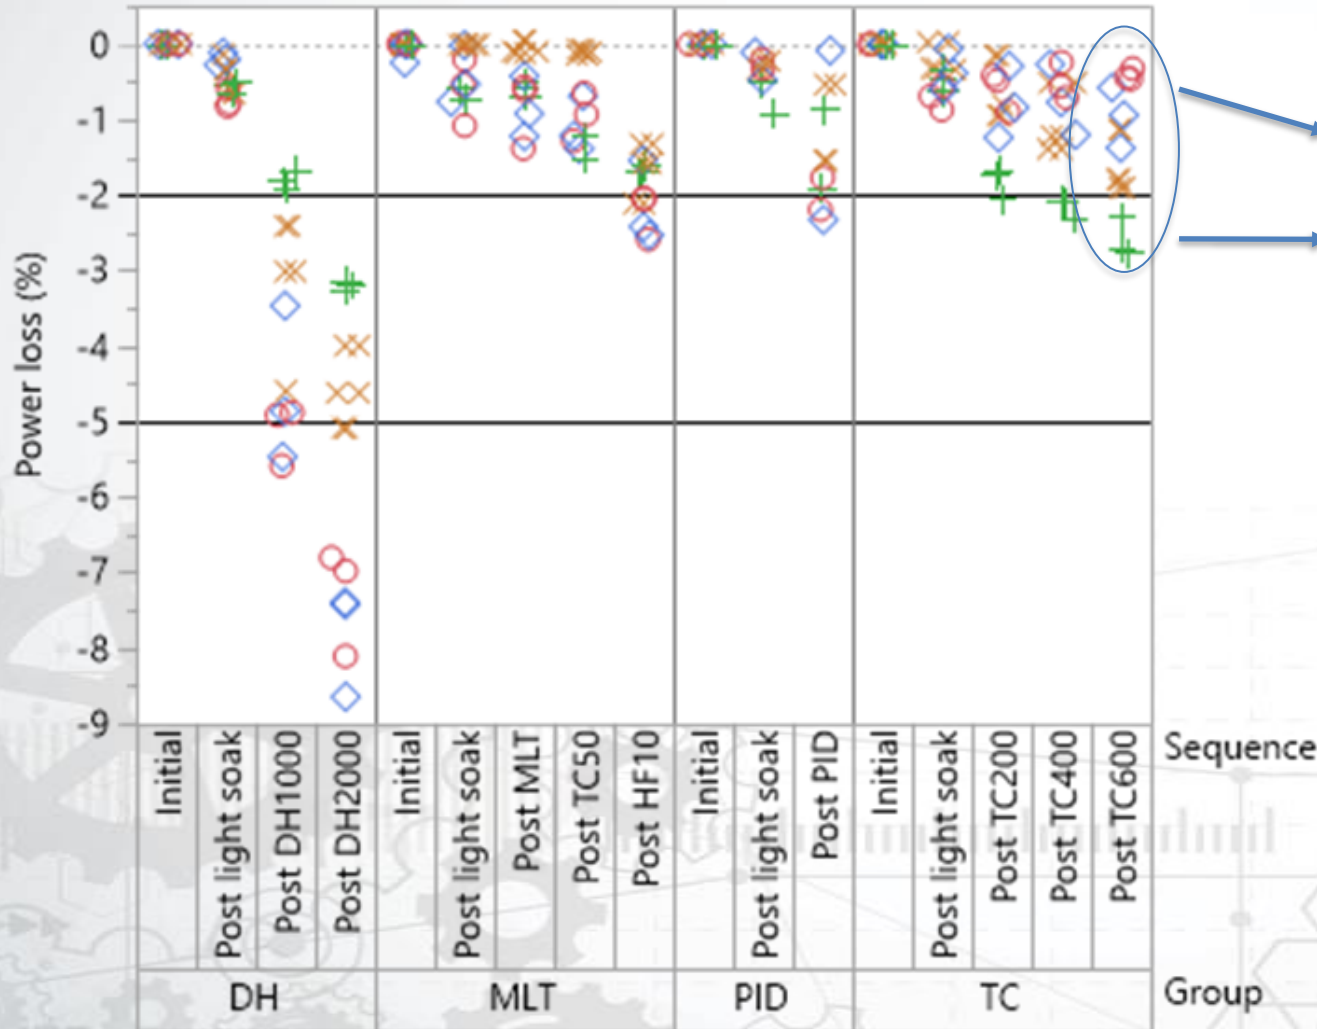
1. Two module BOMs degraded by more than 5% after Damp Heat 2000 hours, but show significant recovery after IEC 61215-2 MQT 19.3
2. In less than 3 months, we have a clear difference in reliability performance following TC600 (-0.5% versus -2.5%)

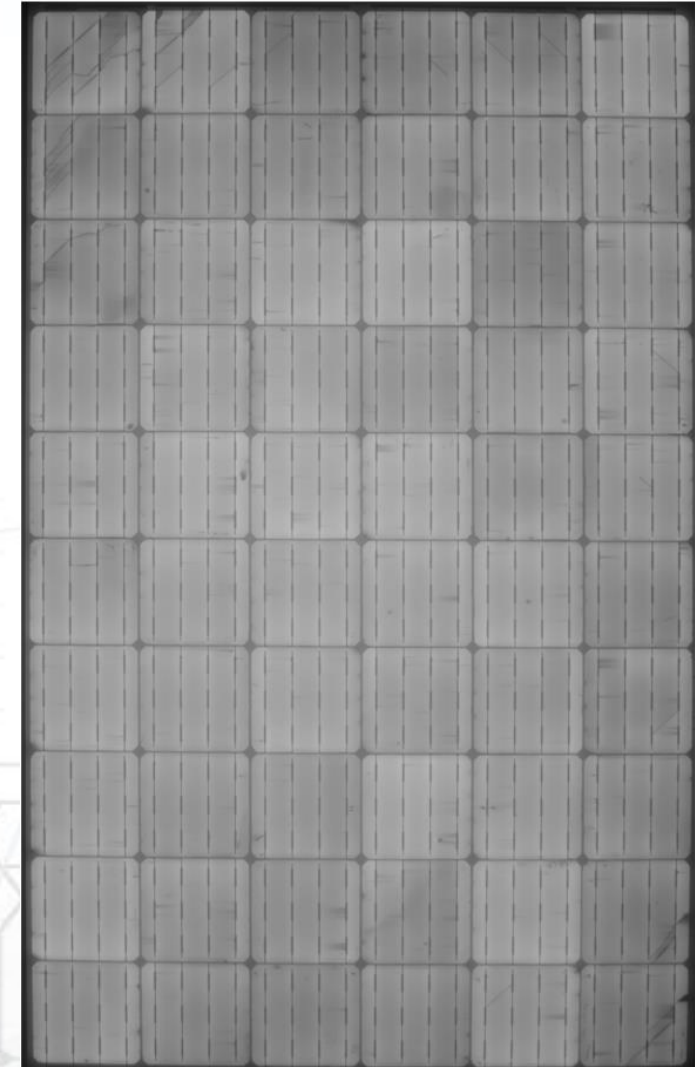
TC600 stress induced unusual pattern in cracked cells

- One BOM showed excessive cracking post TC600
 - 44 cracked cells on three modules post TC600
 - Micro cracks can lead to excessive power loss over time
 - Framing issue?

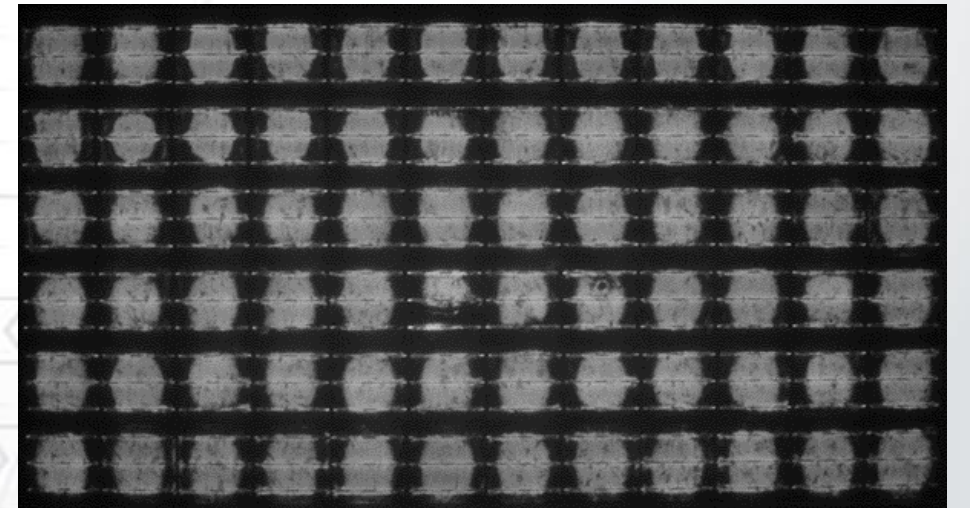
Post
HF10

1. Fielded modules may be tested for handover/re-sale/warranty claims/faults/etc.
2. Damp heat (1000 hours) -> 60% power loss
3. Humidity freeze (10 cycles) -> 40% power loss
